BHAKRA BEAS MANAGENEMT BOARD

**DAM REHABILITATION AND IMPROVEMENT PROJECT
PHASE- II**

BEAS DAM

PROJECT SCREENING TEMPLATE

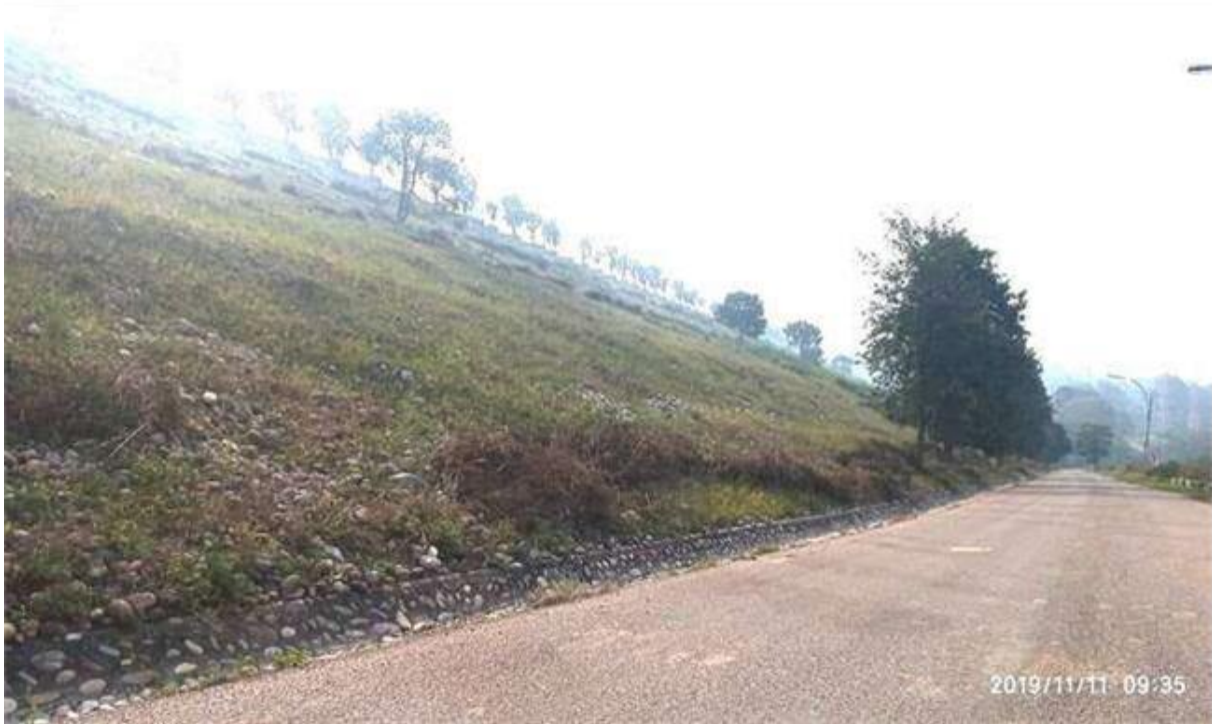
S. No.	Date of Photograph	Description with details of location, nature of distress and other remarks
1.	11-11-2019	Beas Dam is the earth core cum gravel shell Dam having height of 132.59 m above the deepest foundation. The original slope provided at the Downstream face of Beas Dam was 2.5:1. With the passage of time due to erosion as well as weathering action, the original slope has been disturbed. There is deficient of material along the slope at some places and overburden at others. The proposal under consideration has been prepared for the restoration of slope in its original shape as well as providing pitching.

The Downstream view of Pong Dam

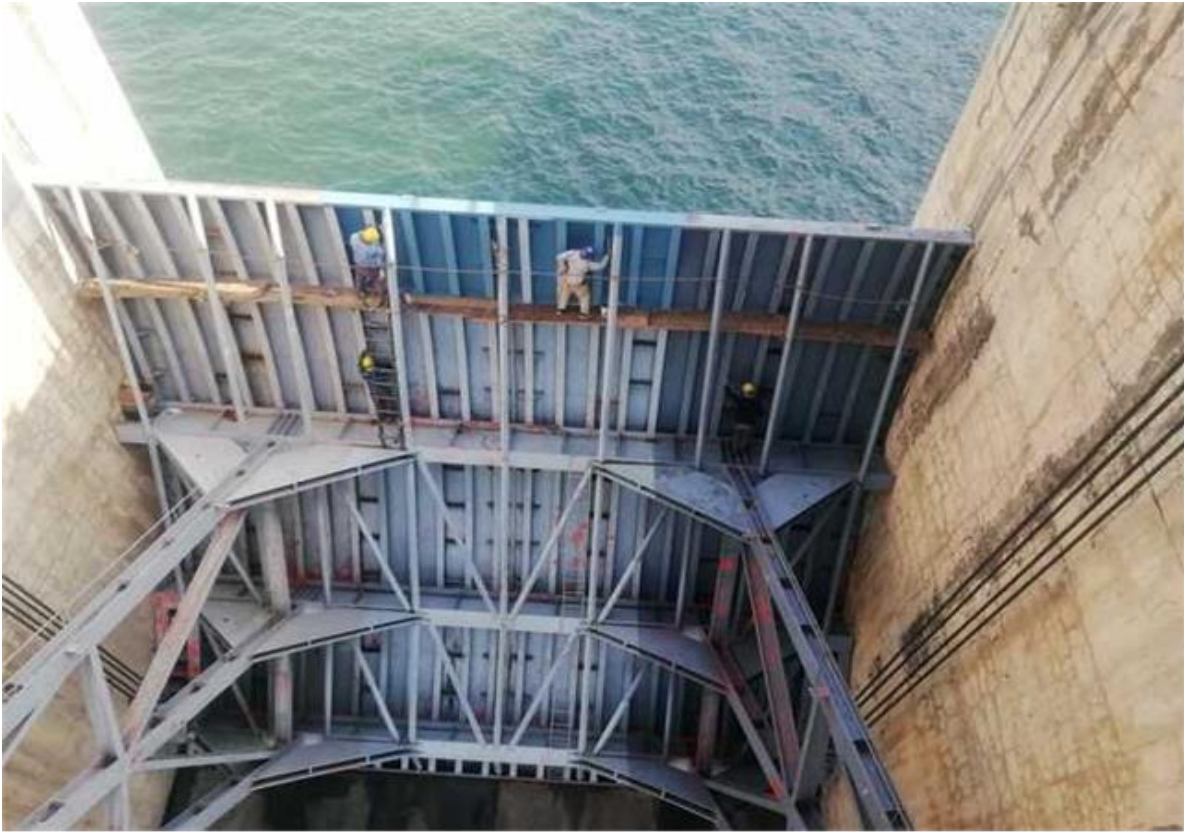
The spillway gate of Pong Dam
